**AIRCRAFT GROUND-FLOTATION INVESTIGATION**  
**PART II. DATA REPORT ON TEST SECTION I**

*U. S. ARMY ENGINEER WATERWAYS EXPERIMENT STATION*

TECHNICAL REPORT AFFDL-TR-66-43, PART II

APRIL 1966

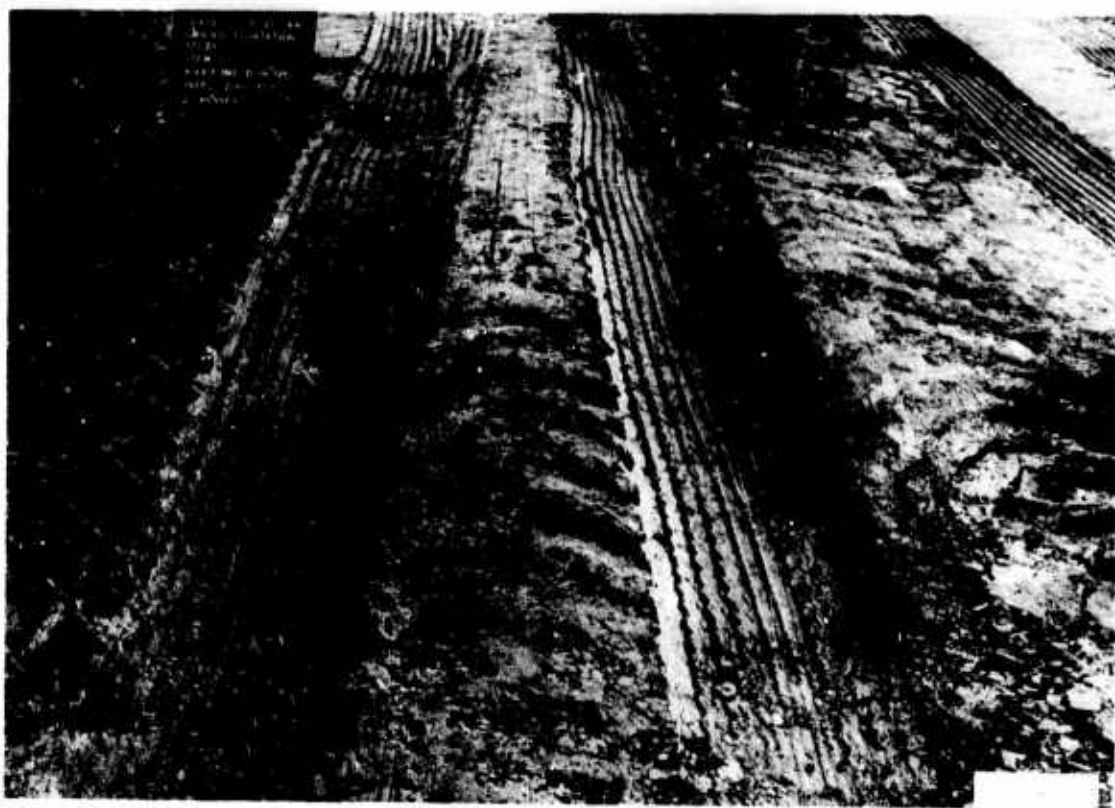
Item 1. The average subgrade CBR was 10 for the top 12 in. of soil in item 1 prior to traffic. The test vehicle caused severe rutting after two passes made in an attempt to record 0-coverage drawbar pull values. Rut depths exceeded 6 in., and the item was considered failed at two passes ( **Figure 2** ).

**Figure 2.** Lane 1, item 1, at two passes (failure)

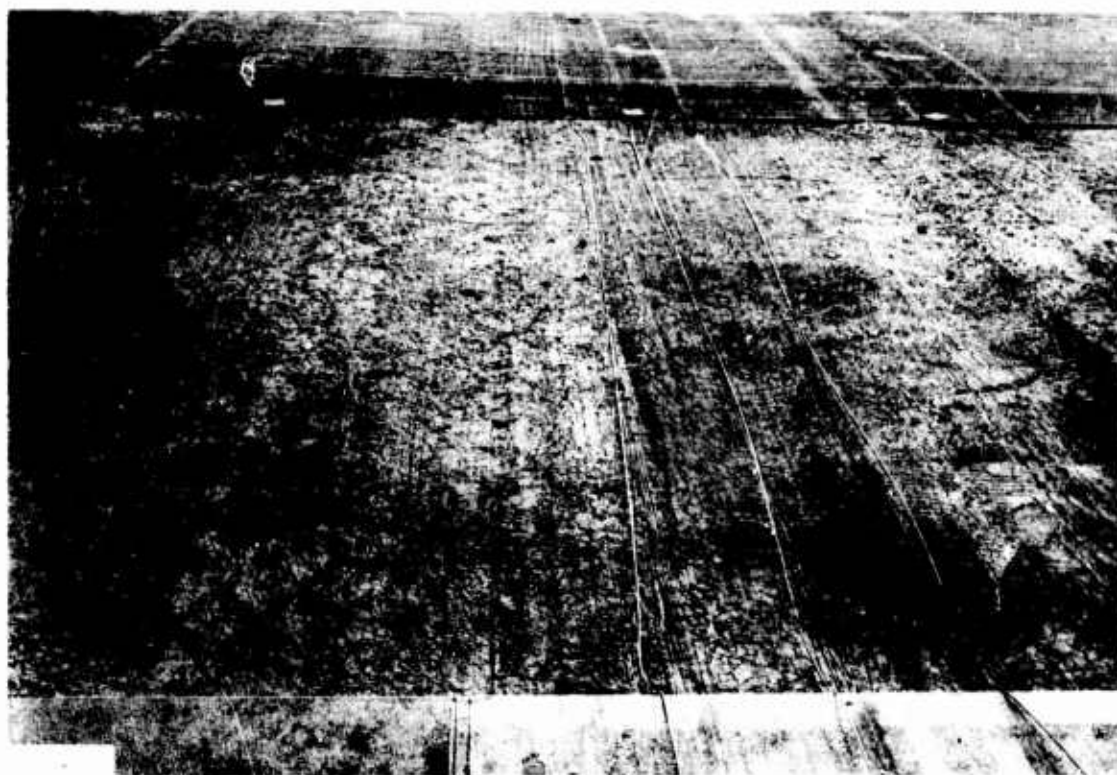
Item 2. The average subgrade CBR was 15 for the top 12 in. of soil in item 2 prior to traffic. Slight rutting of the surface resulted from two passes of the load vehicle during 0-coverage drawbar pull tests. After 20 coverages, the entire item had depressed in the tracked lane approximately 1 in. and the surface was relatively flat and in very good condition ( **Figure 3** ). A reduced rate of soil depression continued throughout the traffic period. At 40 coverages, the average CBR had increased to 34 for the top 12 in. of soil. Slight rutting of the surface was evident when traffic was suspended at 300 coverages, but the overall condition of the item remained good ( **Figure 4** ) and it was not considered failed. The traffic was discontinued because the CBR was increasing with traffic, and an excessive amount of time would have been required to develop a failure. The rated CBR of the item was 27 after 300 coverages of the test vehicle.

**Figure 3.** Lane 1, item 2, at 20 coverages

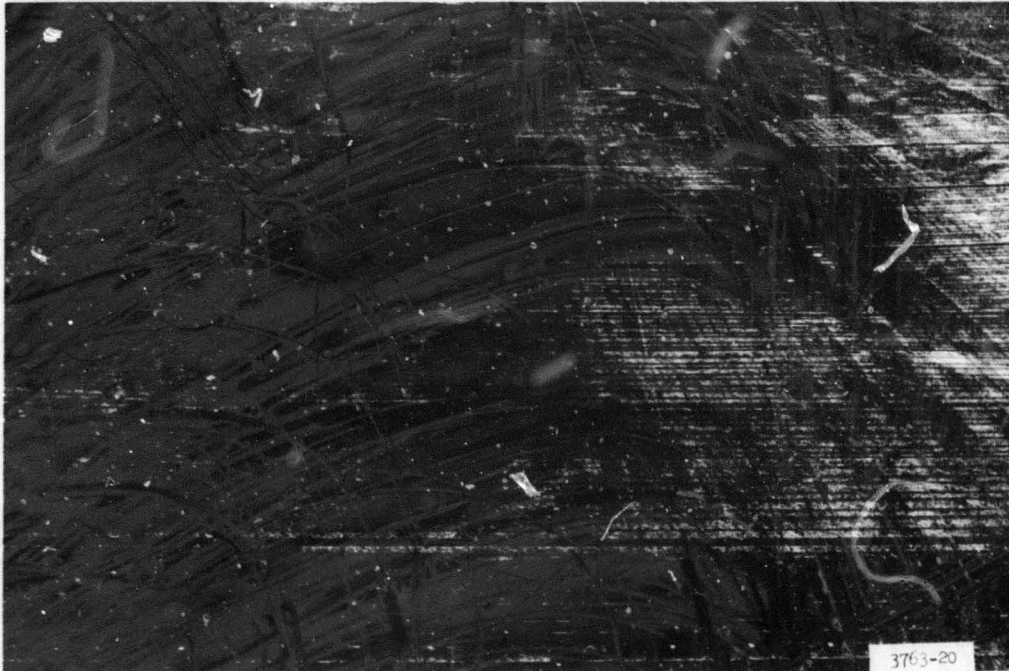
Item 3. Item 3 prior to traffic is shown in **Figure 5**. After 20 coverages, there were slight differential mat deformations along with an initial soil depression of about 1 in. No significant mat damage was evident with continued traffic to 100 coverages. At 135 coverages, sheared rivets and increasing differential deformations were noted. At 200 coverages, cracks appeared in the mat surface, but the item remained in serviceable condition. Traffic was continued to 300 coverages, at which time the mat was considered failed due to excessive roughness and mat deterioration ( **Figures 6 and 7** ). The rated CBR for the item was 7.4.

- a. Roughness. At 300 coverages, longitudinal, transverse, and diagonal differential deformations were 2.00, 1.75, and 2.25 in., respectively (see table 1).

**Figure 6.** Lane 1, item 3, at 300 coverages (failure).  
Transverse straightedge shows roughness

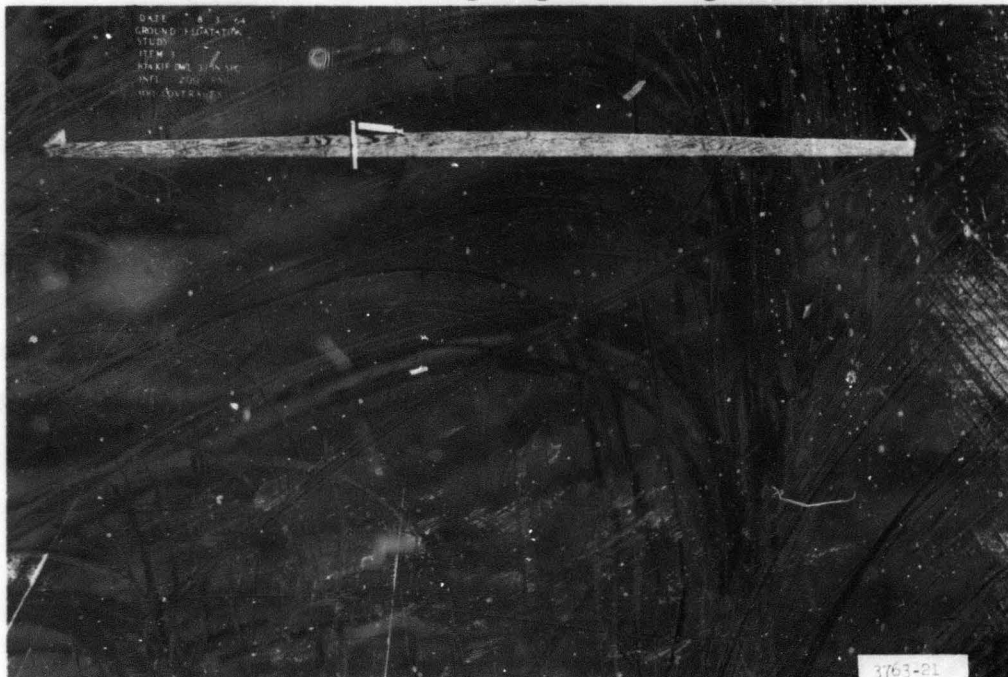
- b. Deformation. Mat deformations are shown in **Fig 21**. The mat cross section progressively assumed a trough shape as trafficking proceeded, reaching a maximum deformation of 2.8 in. Development of longitudinal deformation is indicated in **Fig 22**. The maximum deformation measured along this direction was 3.0 in.

**Figure 7.** Lane 1, item 3, at 300 coverages (failure).  
Longitudinal straightedge shows deformation

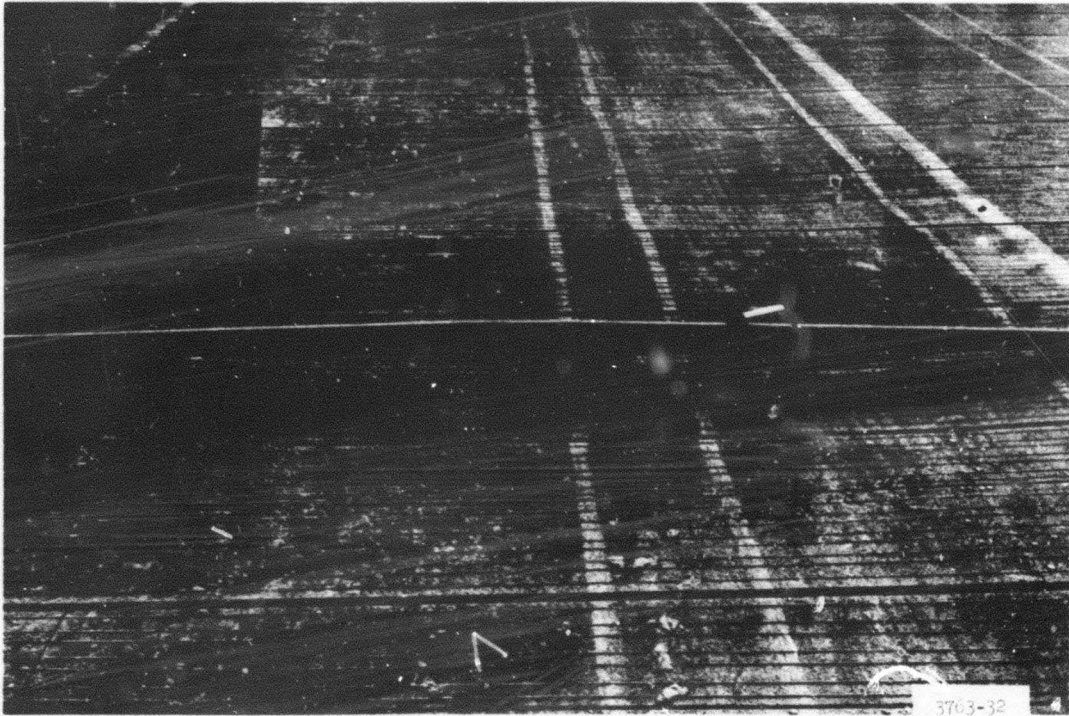
Item 3. Item 3 prior to traffic is shown in **Figure 12.** At 20 coverages, rivet breakage had begun, and there was evidence of subgrade material being extruded upward through the joints of the mat. The greatest rivet damage was along the center lines of the individual mat panels. At 40 coverages, item 3 was considered failed due to roughness and mat deterioration (**Figures 13 and 14**). The rated CBR of the item was 8.7.

**Figure 14.** Lane 2, item 3, at 40 coverages (failure).  
Transverse straightedge shows deformation

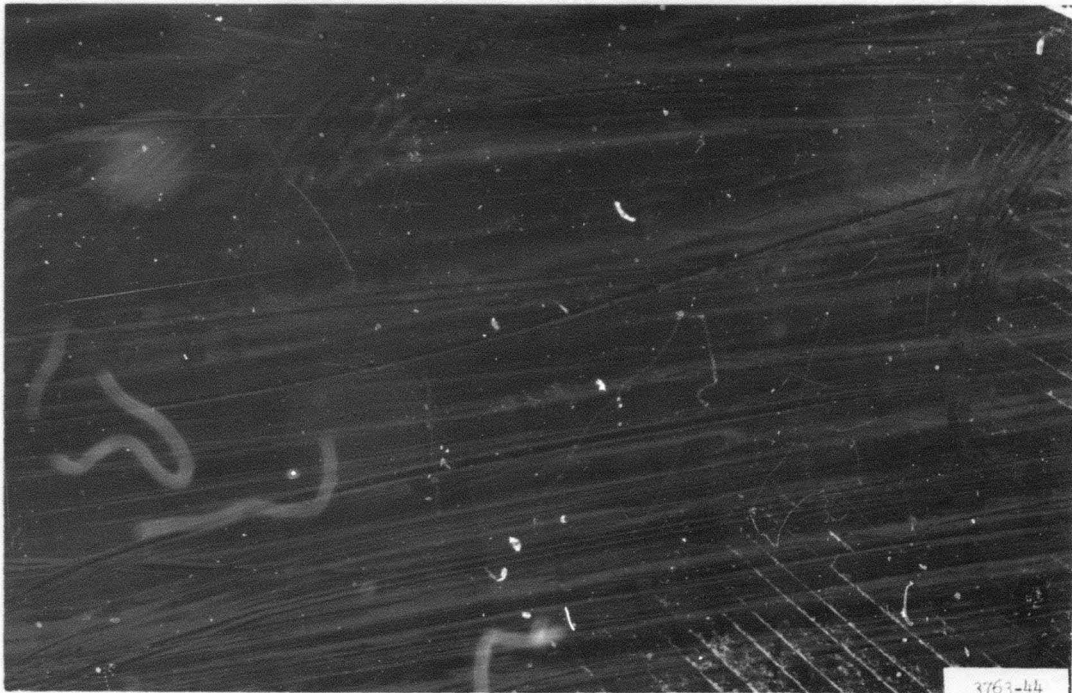
To observe the rate of mat deterioration under postfailure conditions, an additional 28 coverages of traffic were applied to item 3. Severe mat damage was rapid, and panels separated along their center lines (**Figure 15**). Shearing of drive rivets in end connectors occurred just outside the traffic lane, allowing the panel end joints to open (**Figure 16**). At 68 coverages, movement of the load vehicle over the item had become difficult, and traffic was suspended.

**Figure 15.** Lane 2, item 3, failed area at 68 coverages  
(28 postfailure coverages)

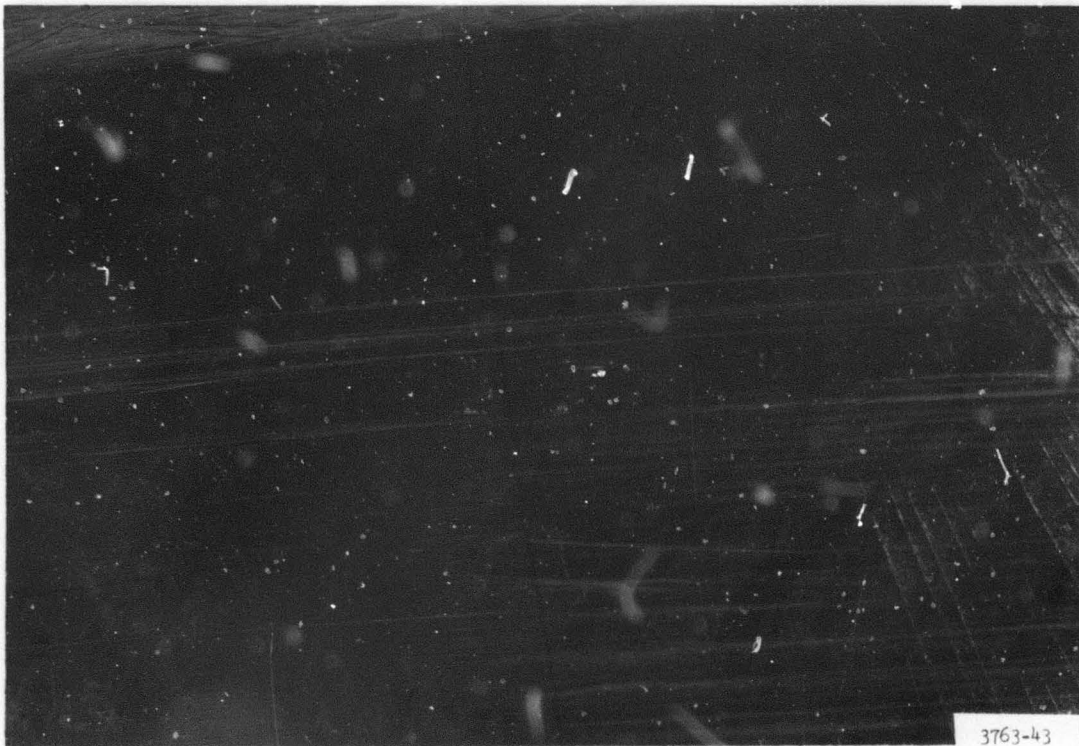
**Figure 16.** Lane 2, item 3, at 68 coverages (28 postfailure coverages).  
Longitudinal straightedge shows roughness and mat deformation

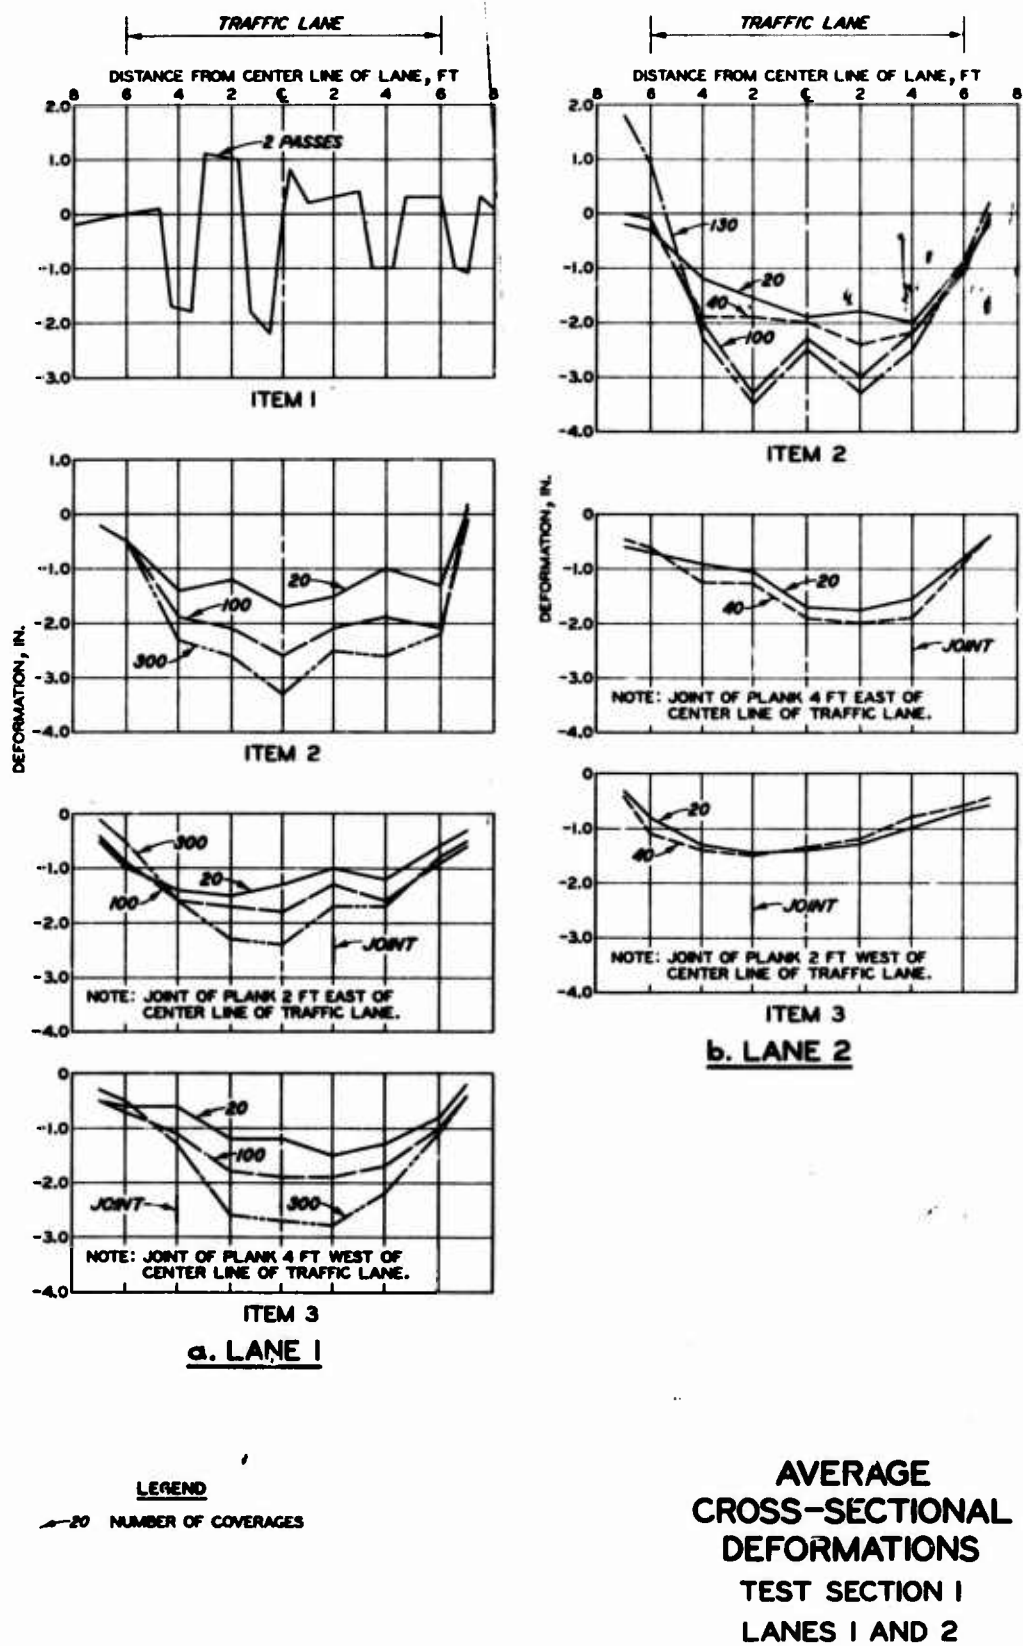
Figure 21

Item 1. No uniform traffic coverage was possible on item 1, as failure due to severe rutting occurred during preliminary passes made for drawbar pull measurements. The values recorded for drawbar pull are shown in table 1. A cross-section plot showing average soil deformation at failure is shown in **Figure 21**.

- b. Deformation. Average cross-section deformation plots are shown in **Fig 21**. A maximum deformation of 2.0 in. was measured at failure. A profile deformation plot is shown in **Figure 22**.

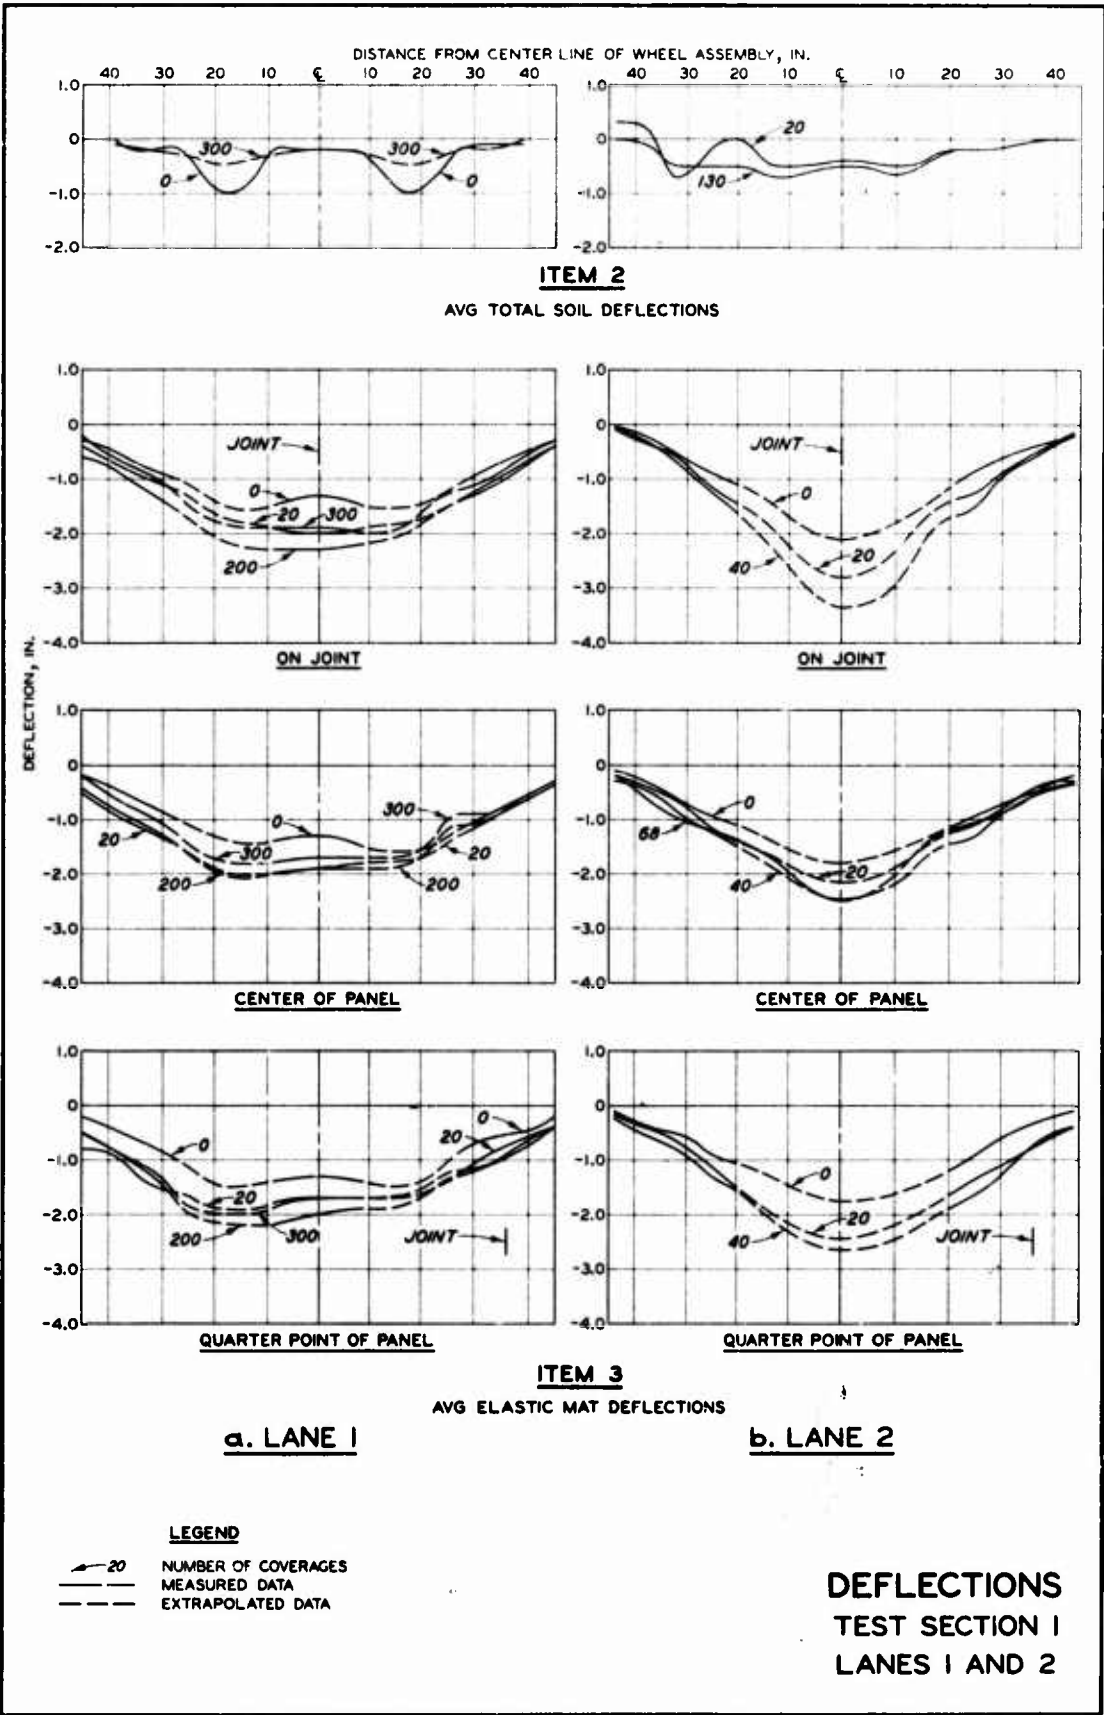
Figure 23

- c. Deflections. Average total soil deflections (total for one loading) are shown in **Fig 23**. Maximum deflections under the load wheels were 1.0 and approximately 0.5 in. at 0 and 300 coverages, respectively. Elastic soil deflection was 0.1 and approximately 0.4 in. at 0 and 300 coverages, respectively.

- c. Deflection. Total soil deflections under the load wheels are shown in **Fig 23**. Maximum total deflection of about 0.7 in. was measured beneath the load wheels at 130 coverages. Maximum elastic soil deflection (table 1) was 0.4 in. at 130 coverages.

- c. Deflection. Deflection of the mat under the load wheels increased throughout traffic. The maximum average deflection of 3.4 in. occurred at failure with the wheel assembly centered over panel joints. **Fig 23** shows deflections with the wheel assembly in several positions relative to mat joints. Each of these deflection plots reflects a smooth, concave cross section. Elastic subgrade deflection at failure was 1.8 in. After 28 postfailure coverages, the elastic subgrade deflection was 1.7 in.
